## CBR 150 engine failure.

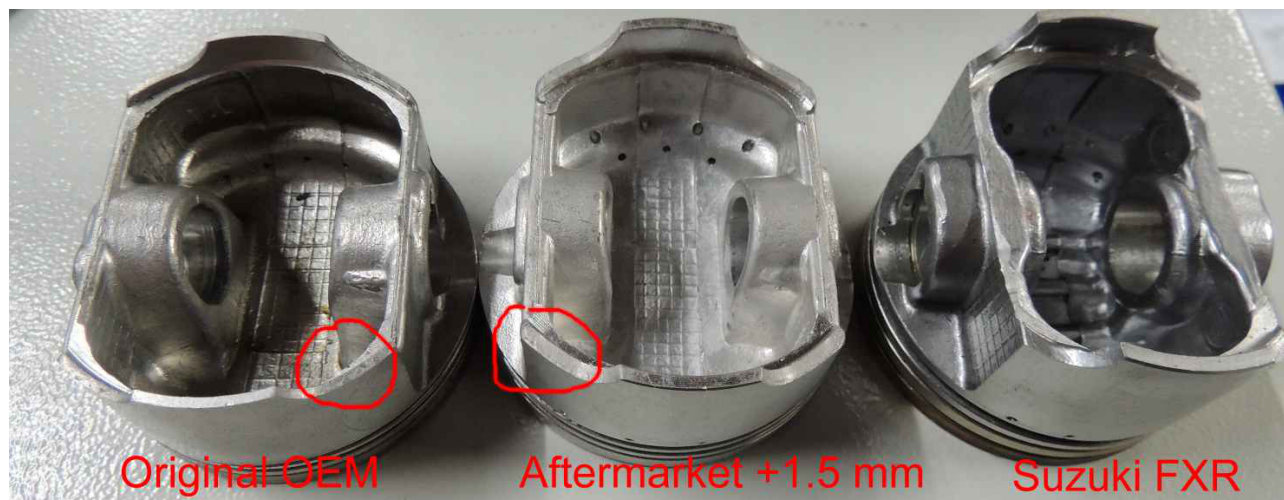
New Piston 124 g old 109 g. The new piston has a thicker side wall. In comparison the FXR pistons are 135g. Their rods do look thinner than the Honda ones.

The bore and stroke is 65 x 47.2. At 14000 RPM this gives a mean piston speed of 22 m/s. This is up there not near the limit. Wikipedia gives– Medium speed petrol ~16m/s, Sport engines and motorcycles ~20-25m/s, Top fuel Dragsters ~30m/s. The after market pistons are Race pistons and I have had no failures with the same brand in 8+ Suzuki FXR engines. The FXR racers tend to keep the std ignition which I believe limits the rpm to 12500. It has a slightly longer stroke and gives a speed of 20.3m/s

When machining the pistons, I found no inclusions in the castings. Visually, they look excellent.

There was one comment that the pistons could have broken around the oil ring groove, but on inspection of the larger parts of piston bits, the oil ring groove is still intact.

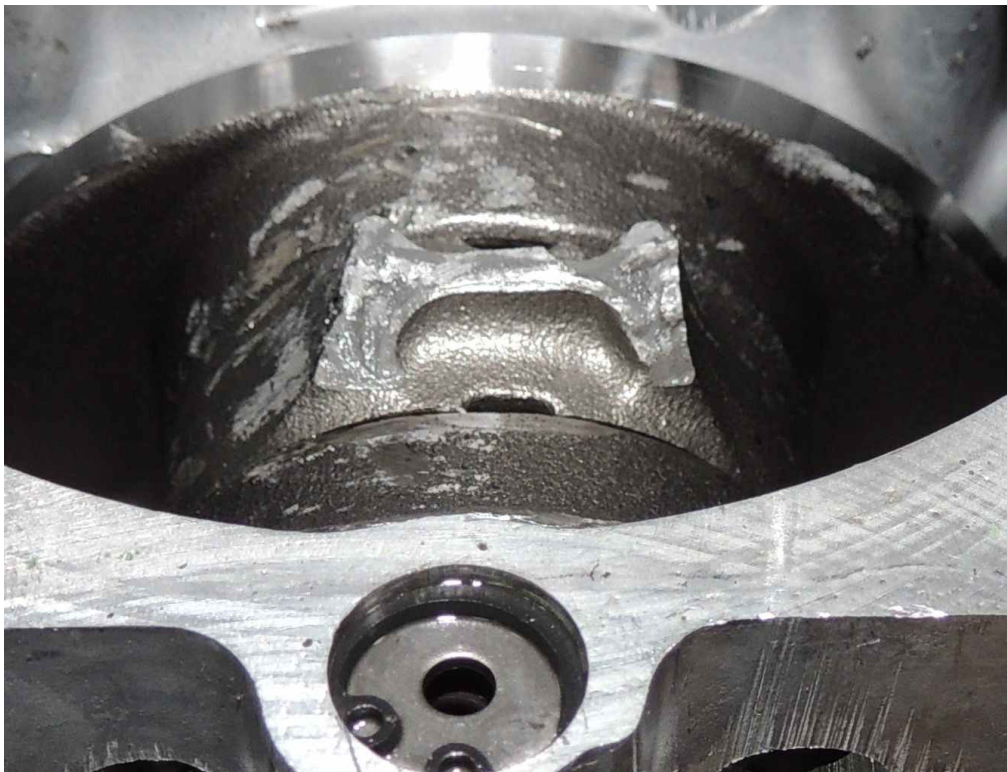
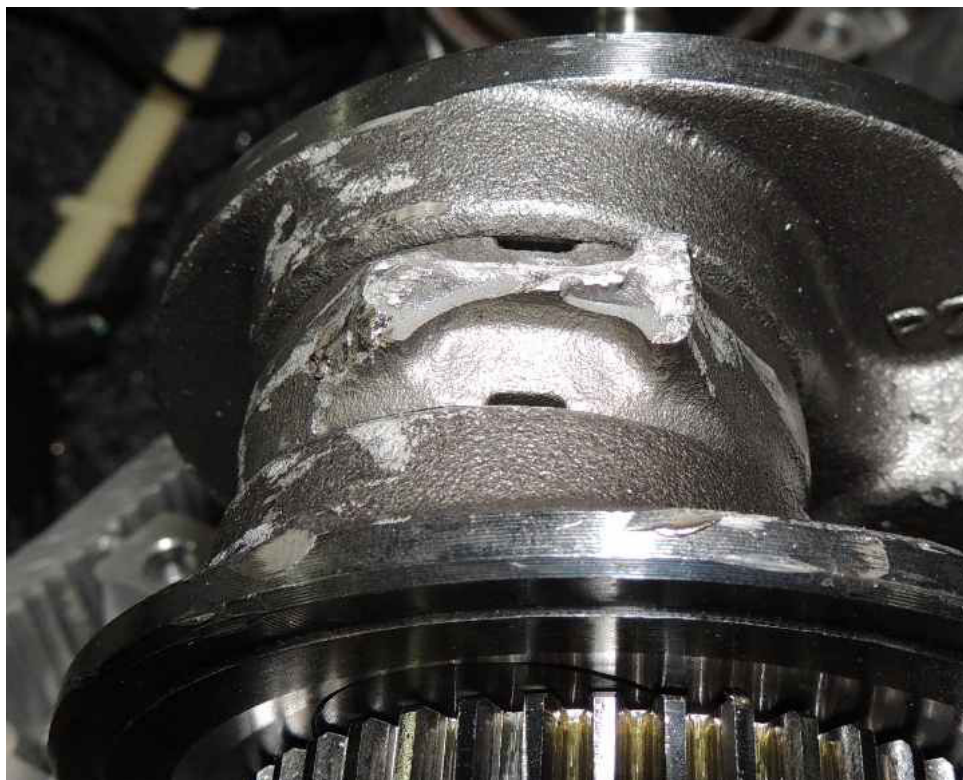
In both cases, the Honda's big ends still rotate freely. Both however, have the conrod broken off at the same spot, right at the base of the rod. This was either due to the crank spinning freely and hitting something in the engine casing and this spot was the weakest point or, metal failure. PS the small ends look fine in both cases ie no overheating evident.

The rod has broke at the thick/strongest side near the base where there would be limited flex.

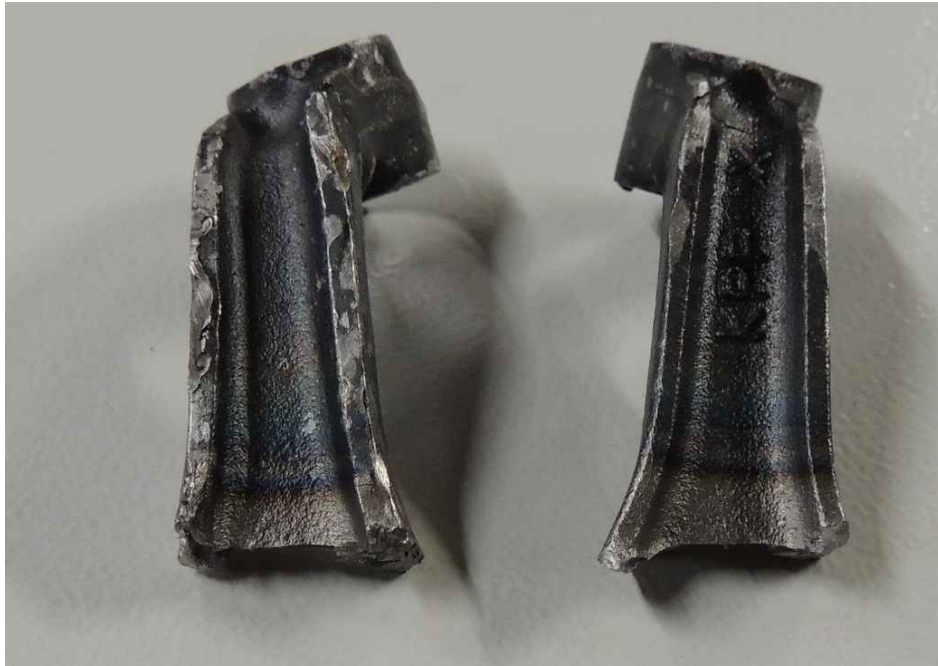
The rod has been heat treated. It is interesting to see that the breakage is next to the HAZ, heat affected zone. My gut feel is that the rod snapped at the HAZ where the metal structure has been compromised. The other possible reason is, if the piston broke and while the rod was still in one piece, for it to break, it must have hit some other engine component. (I cant see any internal bits that could have been hit !). If this was the case, the front of the break would split open and then as the rod was torn off, the rear of the break would show signs of being peeled back before finally separating. There is nothing like this at all. It looks like a straight tension break so we are back to the HAZ breakage. See the red arrow on the rod below for metal tearing example.

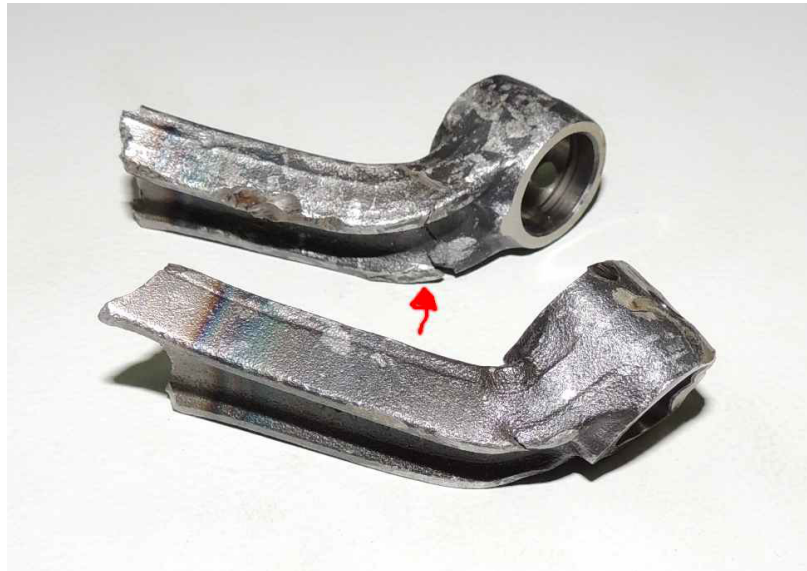
'What do the rods look like Wallace - are they "bronze" coloured full length or silver coloured around the BE with blue coloured beam ? If the latter - this is your problem - a recent trend in cheaper engines is to case harden the whole rod then anneal back the beam - which leaves the BE hard on the inside & out with less ductile "core" thickness. ( Saves money on copper plating )

The Honda rods are the latter and this could have create a HAZ. All the after market ones I fit to the FZR from Japan are copper plated.

The rod's break is not at the narrowest point. Possibly the bigends could have worn slightly oval and this extra up down movement added to the rod stress. Not sure

My suggestion will be to keep the STD CDI box with rev limiter.  
Any comments, please reply to my email
